D. Clark Arboriculture
2741 The Rise Victoria B.C. V8T-3T4
(250)474-1552 (250)208-1568
clarkarbor@gmail.com
www.dclarkarboriculture.com
Certified Arborist PN-6523A
ISA Tree Risk Assessor CTRA 459

For Highbury Asset Management c/o Richard Kiers

1003 Chamberlain St. Victoria BC V8R-1C5

Site visit: Wednesday December 21, 2016

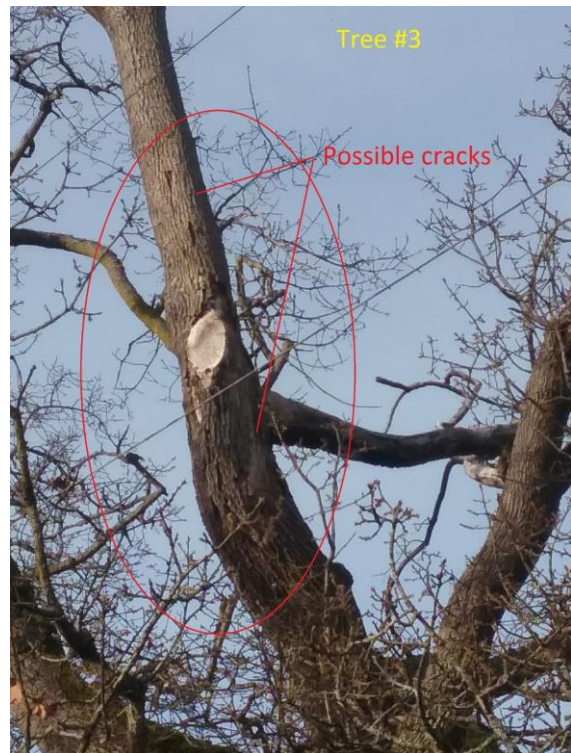
Tree #3 is a Garry Oak (*Quercus garryana*) measuring 83cm/dbh and approximately 22m high. The tree leans southwest toward the primary line. The trunk taper is average and the flare at the base is visible. The tree has been pruned poorly in the past and compartmentalization is poor in places. There is a large dominant stem that has mostly died back on the northerly side of the canopy, likely girdled by decay from a large poor pruning wound. Cracks in the stem are appearing above and below this wound. The southerly stem has poor architecture but healthy bud set and good shoot tip elongation.

Tree #3- Remove. The top portion is largely dead, and cracking at or near the point of attachment, threatening the primary wires. A reduction of this component would remove more than half of the tree and may affect the stability, vigour and vitality of the tree.
