D. Clark Arboriculture
2741 The Rise Victoria B.C. V8T-3T4
(250)474-1552 (250)208-1568
clarkarbor@gmail.com
www.dclarkarboriculture.com
Certified Arborist PN-6523A
ISA Tree Risk Assessor CTRA 459

For Highbury Asset Management c/o Richard Kiers

1003 Chamberlain St. Victoria BC V8R-1C5

Site visit: Wednesday December 21, 2016

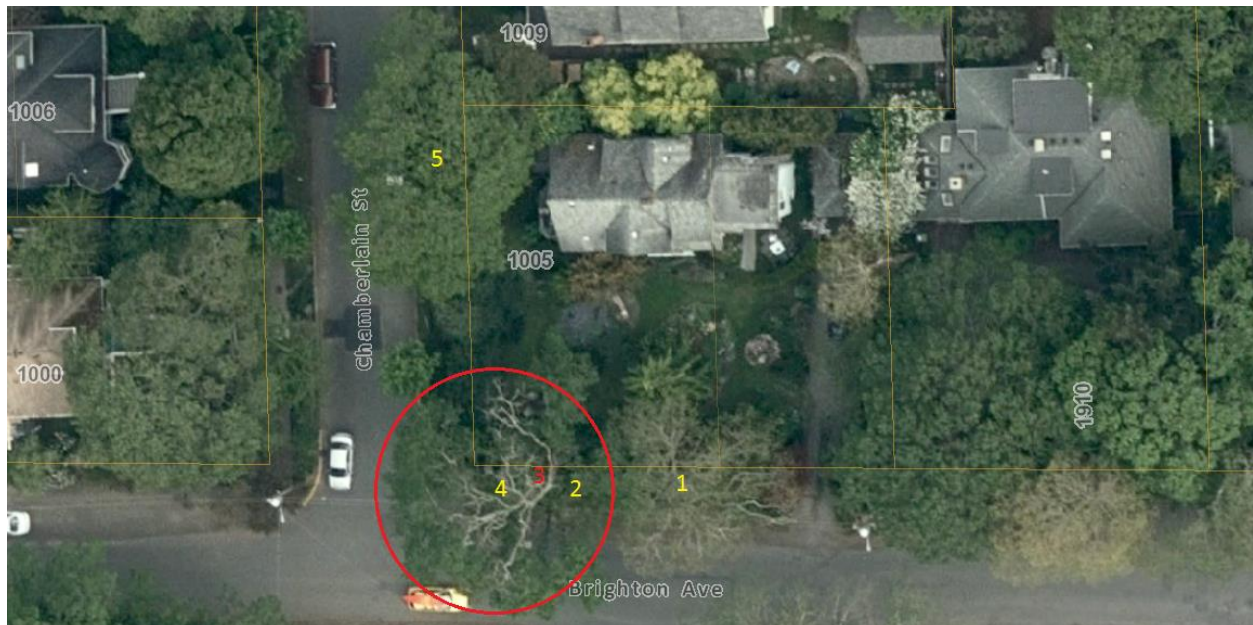
The Garry oaks are located on a landscaped residential lot. Four of the trees are located on the Brighton side of the property (south) and one is located on the Chamberlain side (northwest corner). BC Hydro primary lines run along the south side of the property.
